Lessons from the Ustica investigations

A. Frank Taylor
Cranfield University

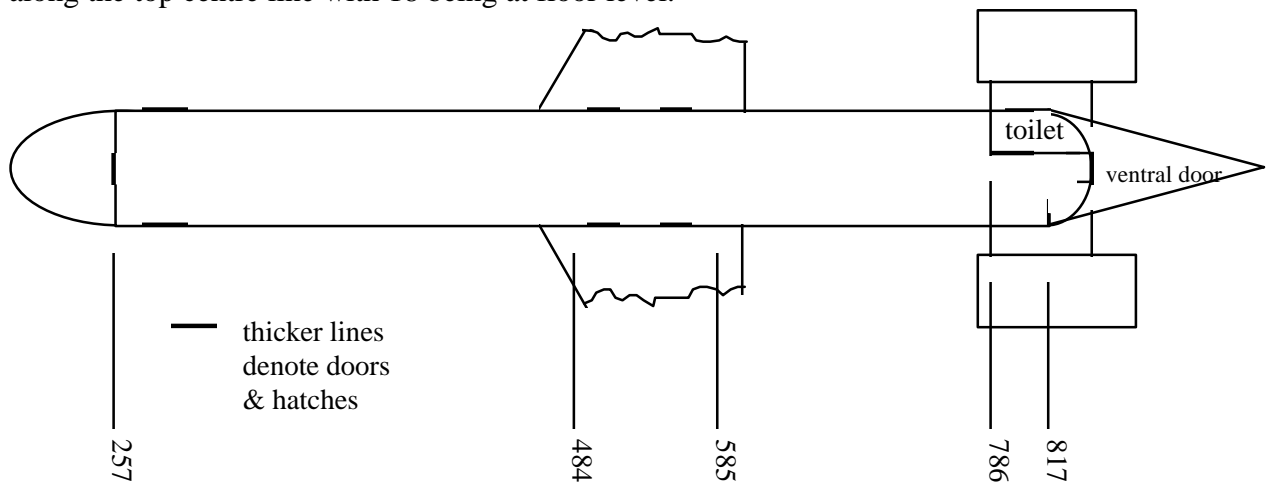
Fuselage station numbers are expressed in inches from the nose and stringer numbers start at 1 along the top centre line with 18 being at floor level.

The station numbers are of particular importance when relating individual pieces to the overall aircraft, certain key station numbers being shown in the figure. As will emerge later the rear fuselage becomes important and of particular interest are items between station 786, which locates both the forward engine mountings and, on the starboard side, the forward wall of the toilet, and station 817 which is where the rear pressure bulkhead joins the fuselage skin, with part of the domed bulkhead itself forming the rear wall of the toilet.
